Minerals Inspection Report

Mine Name: Energy Queen Mine	Permit Number:	M/037/0043	Mine Status:	Inactive
Operator Name: Energy Fuels Resources (USA)	Inspection Date:	04/15/2014	Permit Fees:	Paid
Inspector(s): M. Bradley	Inspection Time:	12:30p	Bond Amount:	\$319,800
Attendee(s): See below	Weather:	Pt. Cldy, cool	Bond Escalation:	09/21/2015
Inspection Purpose: Routine inspection			Prior Inspection:	07/24/2013

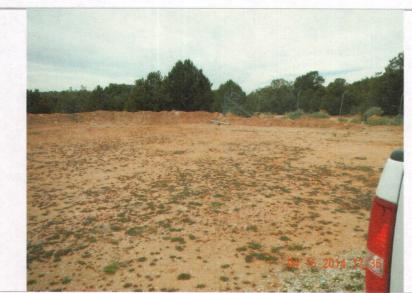
Southwest corner of facility pad; vegetation is predominantly storksbill

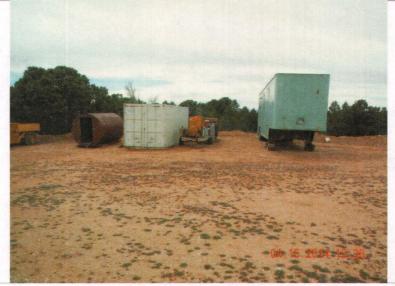
Equipment stored at south side of facility pad

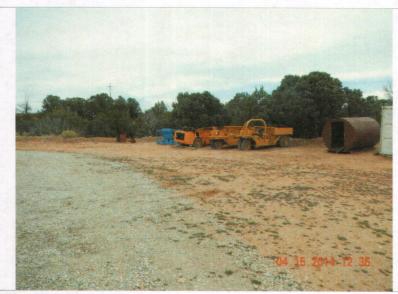
Equipment stored along south side of pad

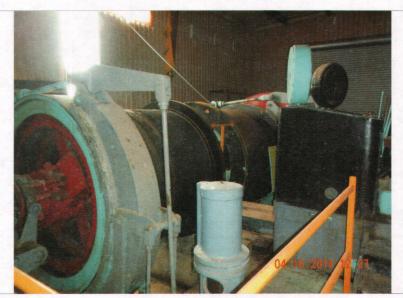
Hoist in main building

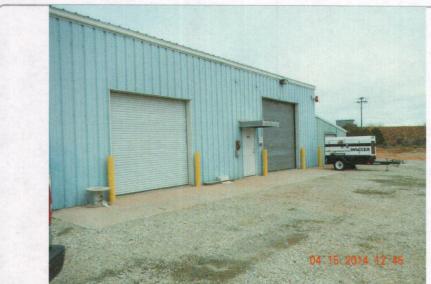
Rear of main building

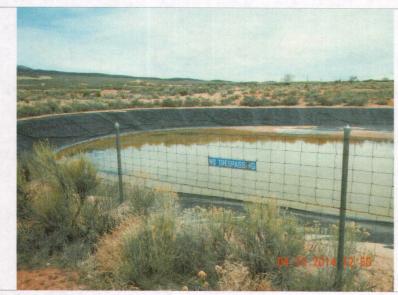
North end of treatment pond

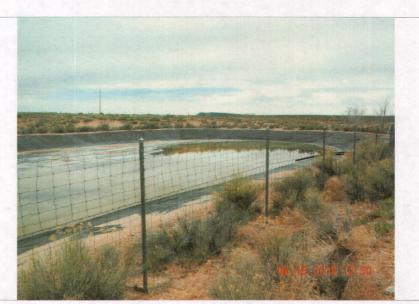
Attendees: Andrea Reither, EFR; Stephen Downs, EFR; Race Fisher, EFR; Todd Eldredge, EFR. No significant changes since last inspection. Grounds developing a cover of storksbill. No visible evidence of eminent threat to public health and safety, or environment. Lined treatment pond has less than a foot of meteoric water.

South half of treatment pond
